APPENDIX D—DESTRUCTIVE ANALYSIS OF JT9D DIFFUSER CASES AFTER EXTENDED SERVICE

D.1 JT9D DIFFUSER SECTIONING PLAN.

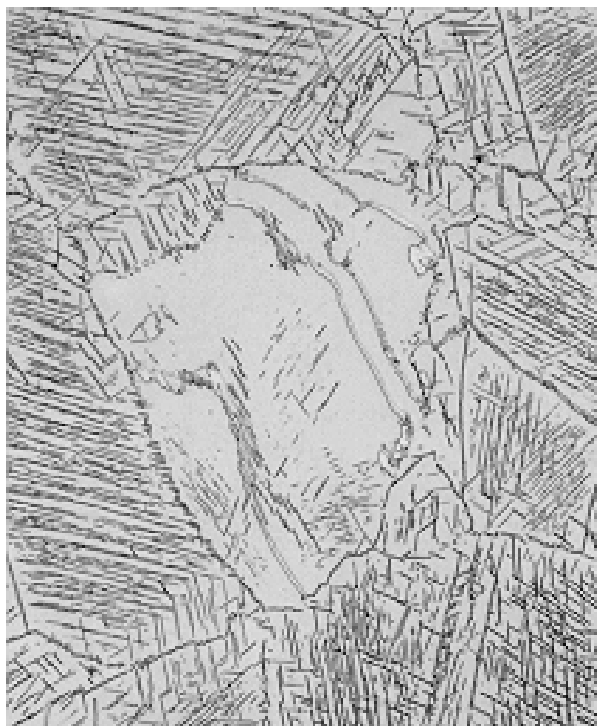
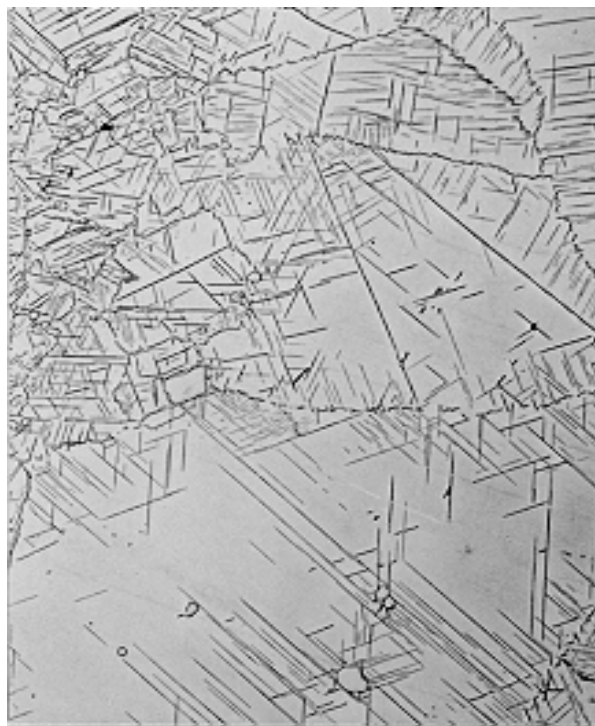
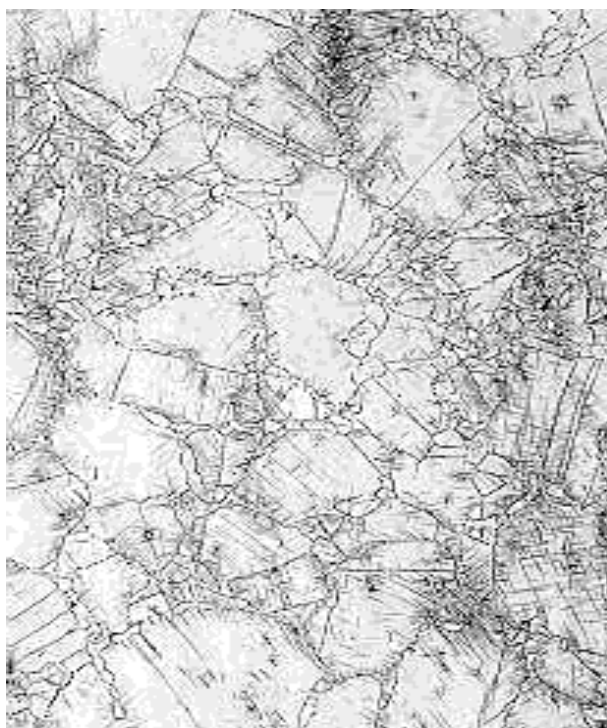
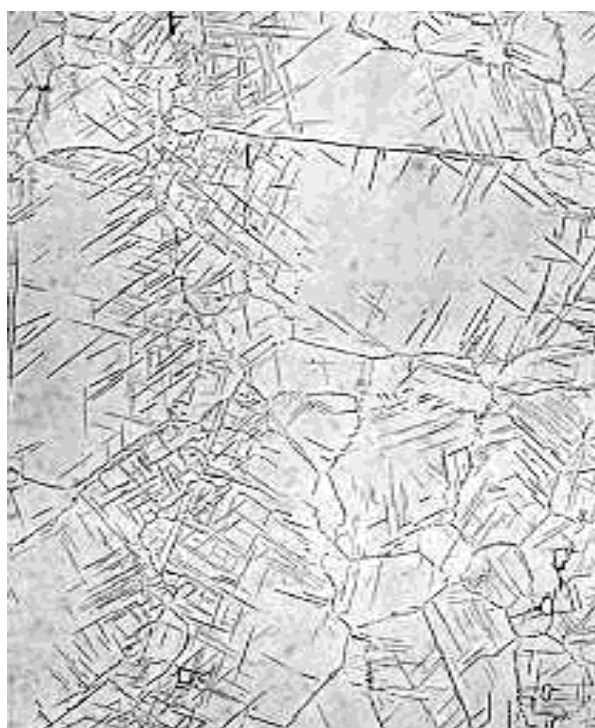
FIGURE D-2. JT9D DIFFUSER S/N AG9961, GENERAL MICROSTRUCTURES OF OUTER PRESSURE WALL DETAILS

All three AMS 5663 details that comprise the outer pressure wall displayed significant banding. The general microstructure was of moderately coarse grains (ASTM 5 and 6) with areas where there was minimal needle delta structure interspersed with bands of high needle delta phase concentrations. Some areas displayed necklace structure, with coarse grains encircled with fine dynamically recrystallized grains. High magnification examination revealed that most grain boundaries were decorated with globular particles, both delta and carbides. Most surfaces displayed a denuded surface layer beneath which was another layer of concentrated needle delta. The denuded layer varied in depth from 0.0006" to 0.0009", while the layer of concentrated needle delta varied in depth from 0.005" to 0.0075".

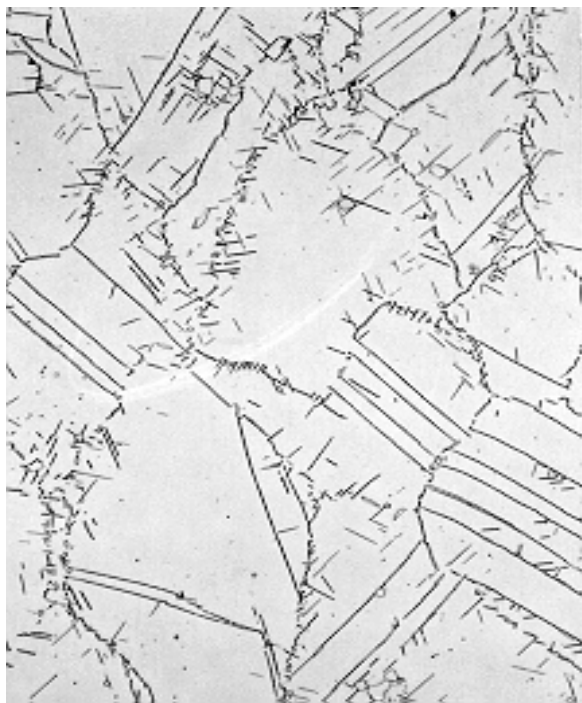
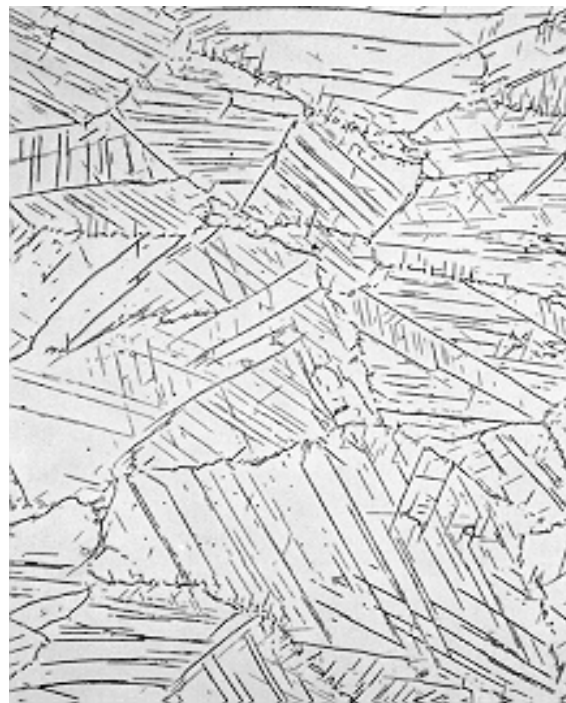
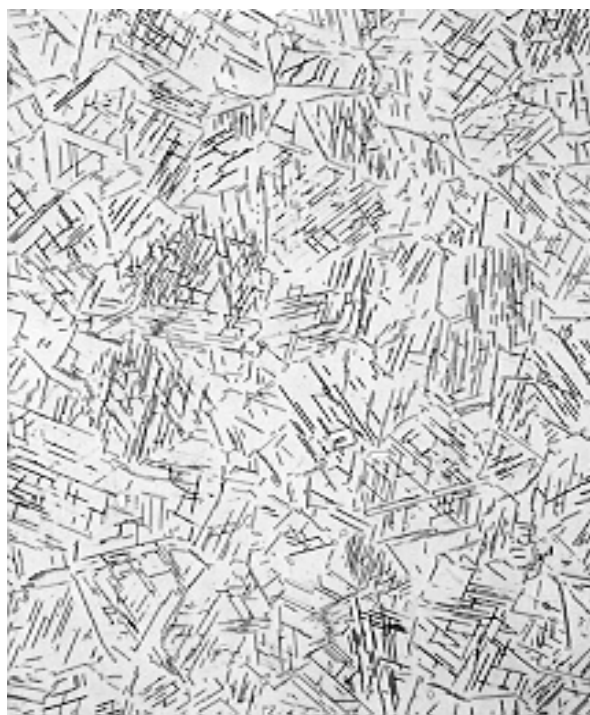
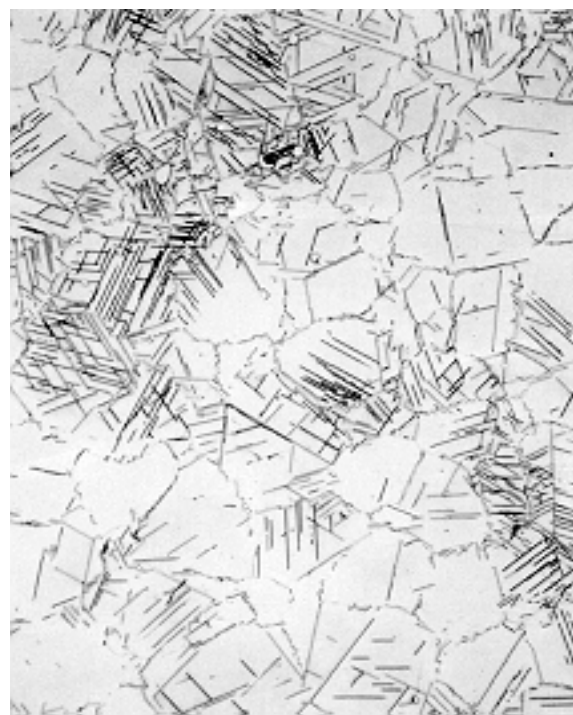
FIGURE D-3. JT9D DIFFUSER S/N AG9961, GENERAL MICROSTRUCTURES OF OUTER REAR (UPPER) AND INNER REAR (LOWER) RING DETAILS

Inner pressure wall AMS 5663 details had a similar banded delta structure, surface denuded layer, and concentrated delta layer. Here the denuded layer depth varied from 0.0004" to 0.0005", and the delta layer varied in depth from 0.0044" to 0.006". The rear ring, which is a rolled sheet of AMS 5596, displayed a finer grain structure (ASTM 8) with lighter banding but an overall high concentration of needle delta throughout the microstructure. The separate attached rear flange was coarse (ASTM 3-4) with less overall needle delta but with concentrations of delta in blotches rather than more continuous bands.

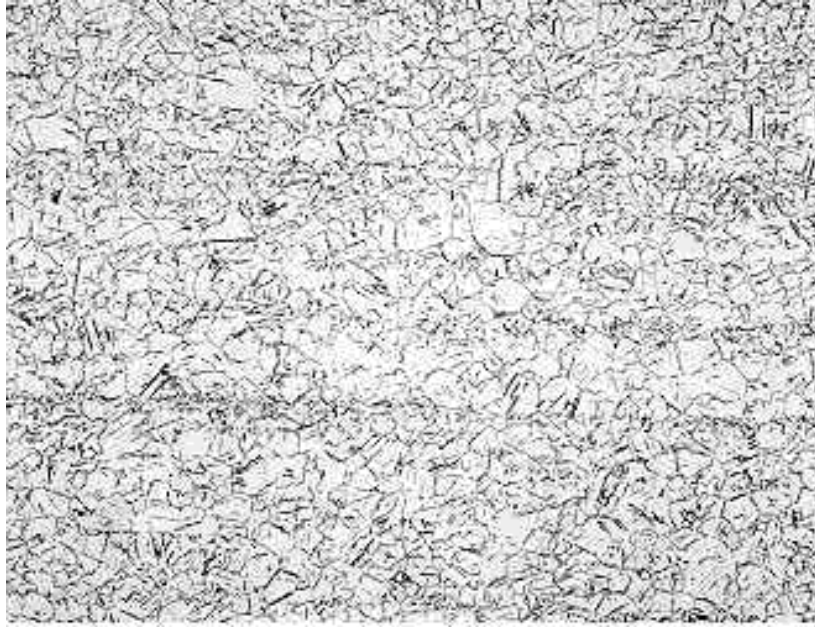
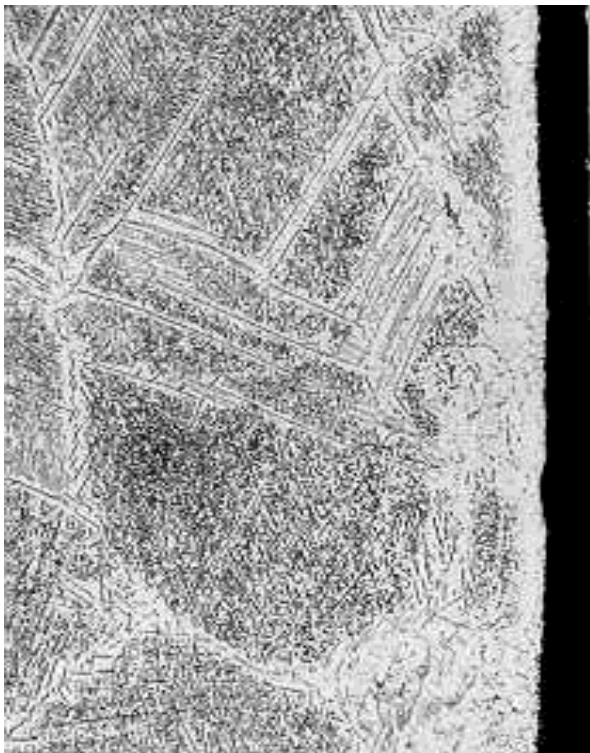
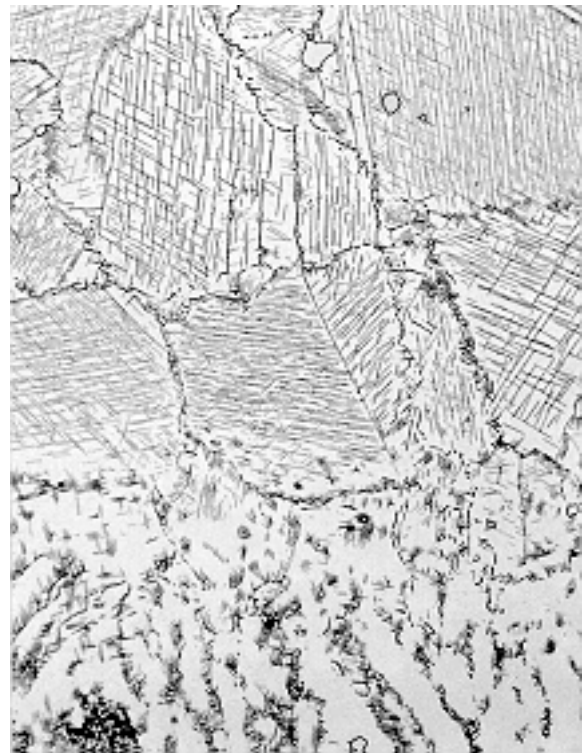
Struts and heat shield details also displayed a fine grain (ASTM 8-10) structure with scattered needle delta and lighter delta bands.

FIGURE D-5. JT9D DIFFUSER S/N AG9961, GENERAL MICROSTRUCTURES OF THE STRUT (UPPER) SHEET MATERIAL AND HEAVY CONCENTRATIONS OF NEEDLE DELTA PHASE ASSOCIATED WITH SOME SURFACES (LOWER LEFT) AND WELD HAZ (LOWER RIGHT)

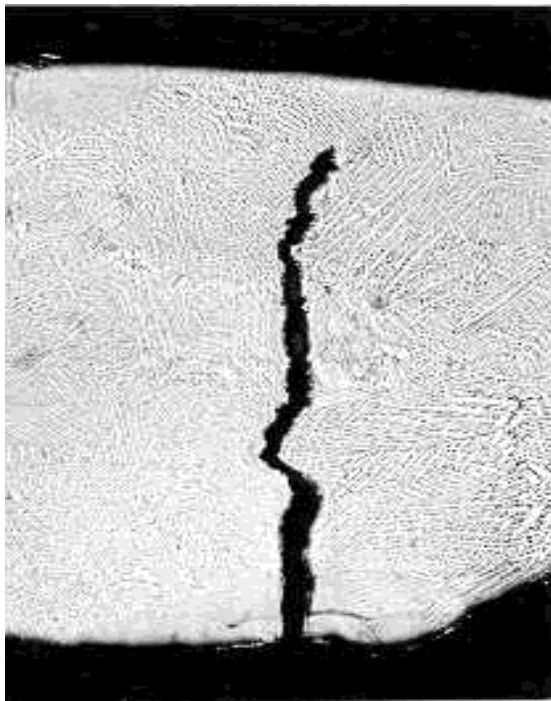
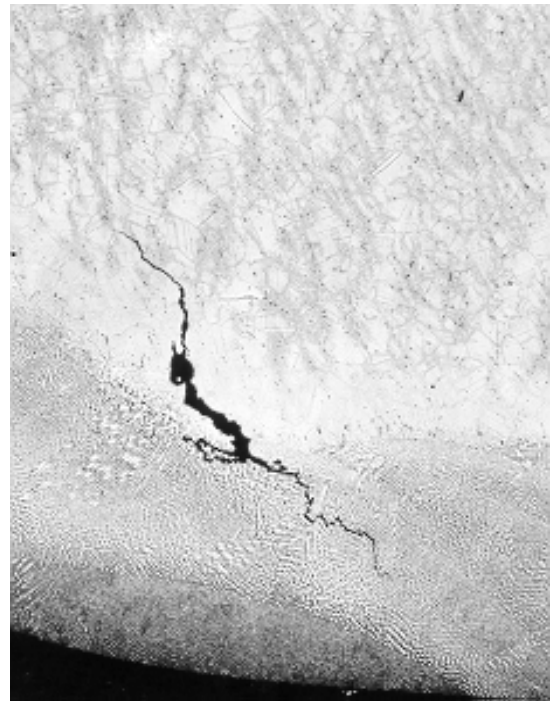
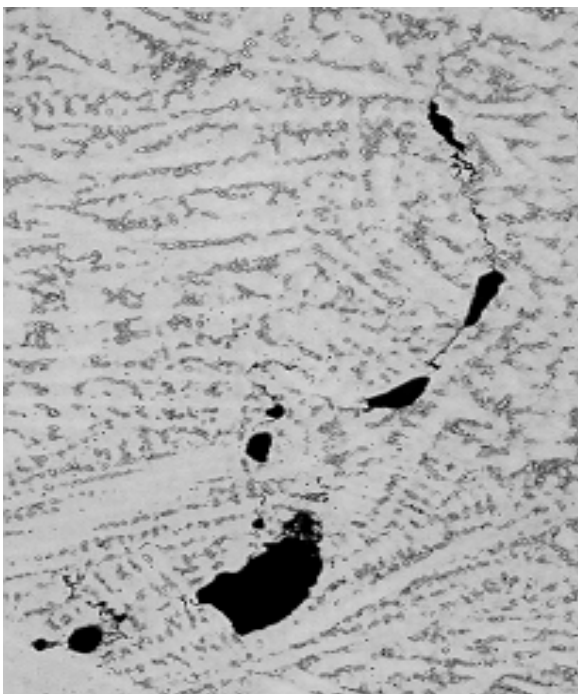
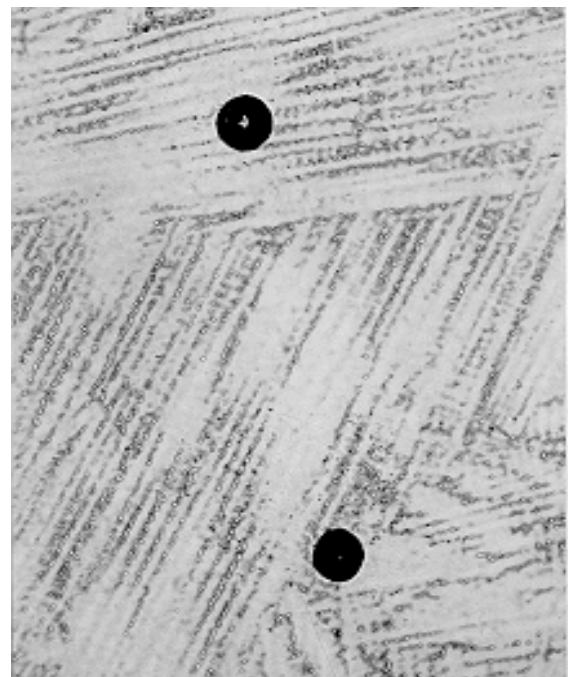
No defects were detected at any of the assembly welds but numerous small defects were detected at most of the repair welds. These consisted of gas pores, near HAZ cracks and cracks in "far" HAZ regions. Many, but not all of the repair welds also displayed heavy concentrations of needle delta adjacent to the welds. Cracking at the tip of the resistance weld that attaches the heat shield to its support bracket was discovered. One large crack was found that extended for more than three-quarters of the thickness of a strut attachment weld. It must be noted that when case S/N AG9961 was scrapped, it contained a number of defects that were left without repair, so it should not be implied that the large weld crack at the strut would not have been detected.

FIGURE D-6. JT9D DIFFUSER S/N AG9961, TYPICAL WELD DEFECTS INCLUDING CRACKS (UPPER), LACK OF FUSION (LOWER LEFT), AND GAS PORES (LOWER RIGHT)

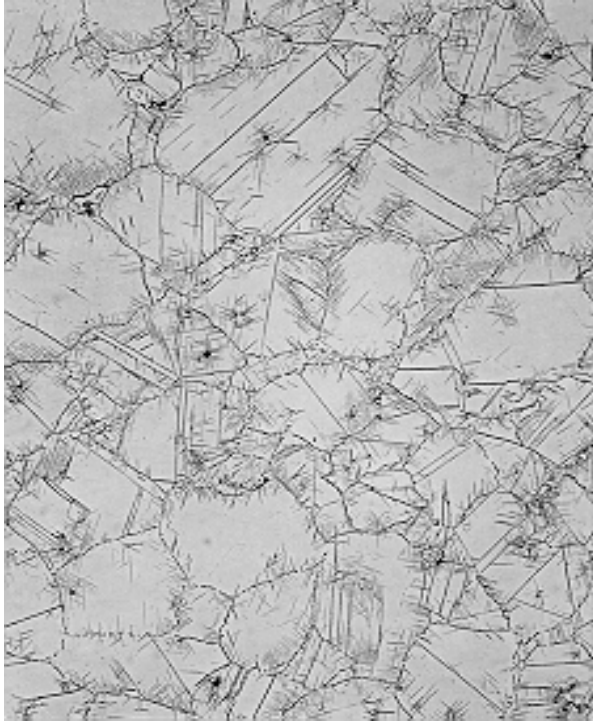
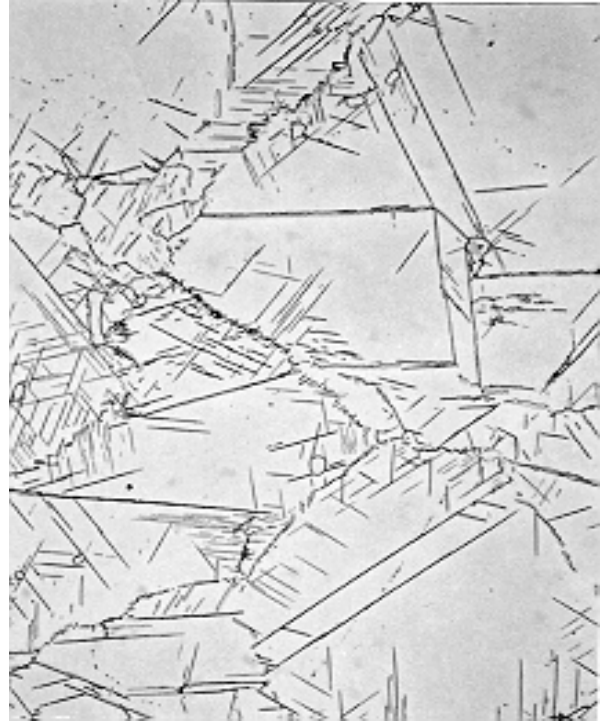
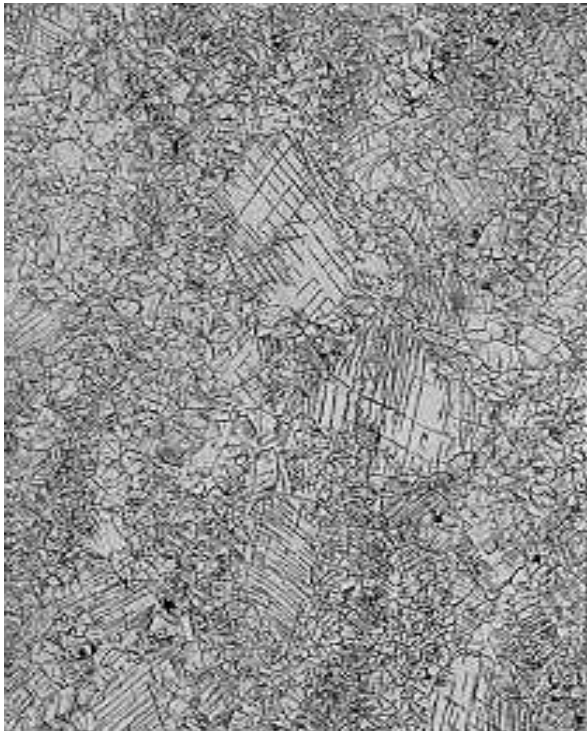
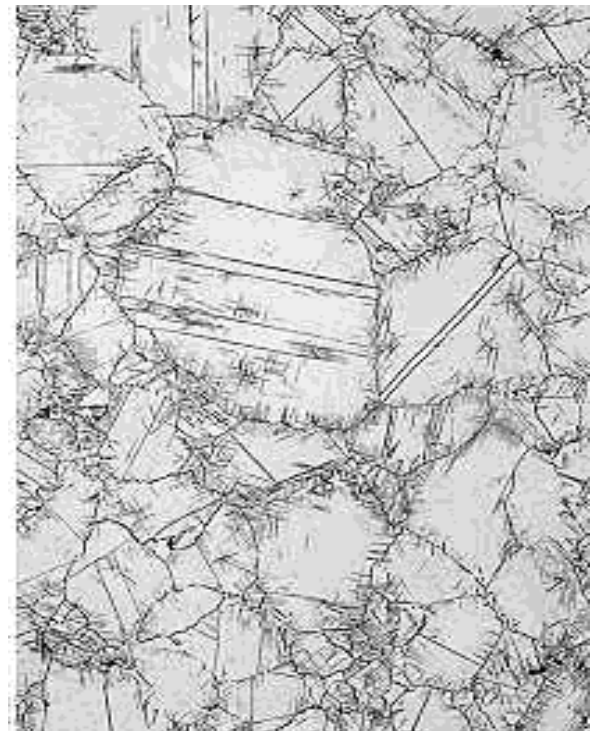
FIGURE D-7. JT9D DIFFUSER S/N BW0976, GENERAL MICROSTRUCTURES OF THE OUTER FRONT SKIRT DETAIL

The forward skirt and front flange of the outer pressure wall displayed a varied amount of needle delta phase. Grain size varied from moderate (ASTM 6) to coarse (ASTM 4), banding was not prominent, but the heavy concentrations of delta along the grain boundaries extended out to create areas of near solid blocks of high needle concentrations. The outer center ring displayed more delta than did the forward skirt, and the rear skirt in turn displayed even heavier concentrations of needle delta than did the center ring. Almost all areas of the outer rear skirt, including the rear flange, displayed a microstructure marked by very high concentrations of needle delta phase. Surface denuded layers varied in depth from 0.0003" to 0.0009", and layers of concentrated delta extended inward from the surface with depths between 0.0030" and

0.0150". The deepest denuded layers and delta plate layers were on the forward skirt. Concentrations of delta needles were also found associated with the threads on the tapped boltholes located on the inner surface of the forward skirt.

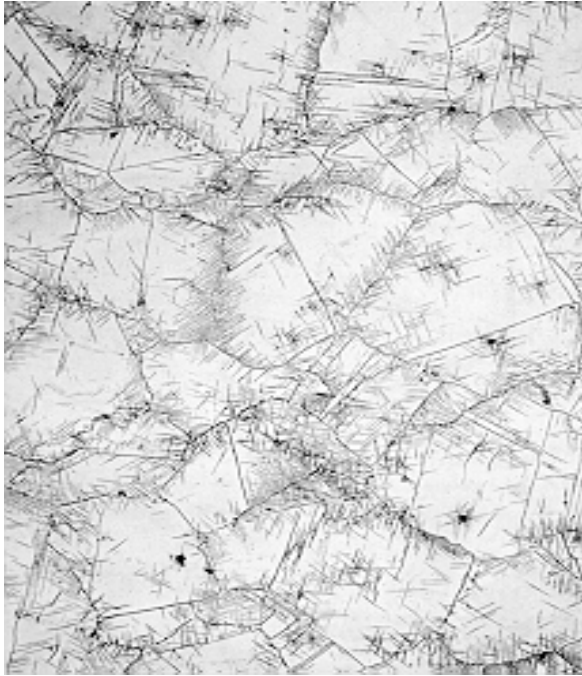
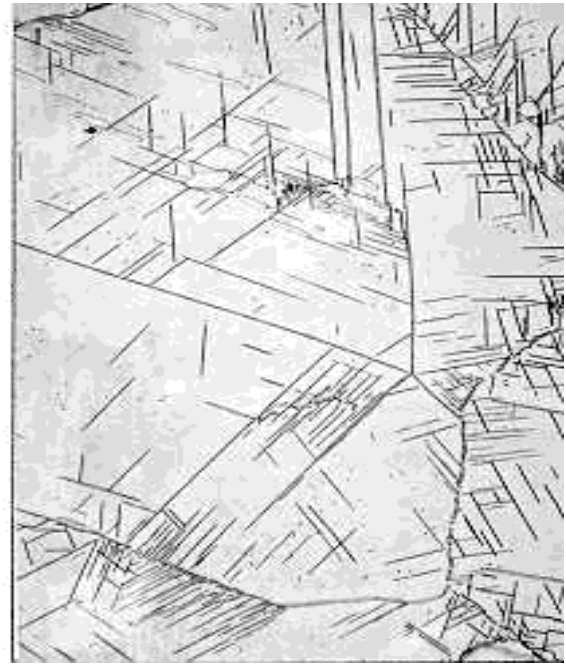
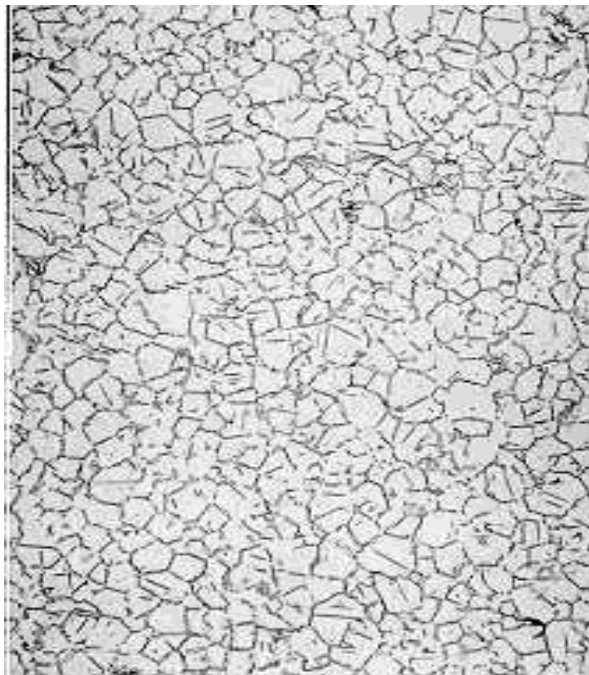
The inner cylinder of case BW0976 presented a myriad of microstructures. The forward flange was a very fine grain (ASTM 10-11) forging that obviously was a replacement for the original integral flange. Microstructure for this piece consisted of globular delta in the grain boundaries and no needle-shaped delta phase. The forward ring was moderately coarse-grained (ASTM 4-6) consisting of generally equiaxed grains with heavy grain boundary needle delta precipitation. Patches of very heavy delta concentrations were observed throughout the material. The rear cylinder (AMS 5596 sheet) was fine grain (ASTM 8-9) with extensive amounts of delta plates scattered somewhat evenly among the microstructure. The separate rear flange was another fine grain (ASTM 11-12) forging with scattered globular delta and no needle delta phase. The heat shield was moderately coarse grain (ASTM 5) while the supporting bracket was much finer (ASTM 6). Both the heat shield and bracket had extensive needle delta phase distributed evenly throughout the microstructure. Surface denuded layers as deep as 0.0009" and surface layers of concentrated needle delta were detected as deep as 0.013". The heat shield also had a shallow oxide layer (0.00015") with oxide spikes or cracks extending into the denuded surface layer. Neither of the very fine-grained flanges displayed any evidence of concentrated needle delta on their respective surfaces but did display a denuded surface layer.

FIGURE D-9. JT9D DIFFUSER S/N BW0976, GENERAL MICROSTRUCTURES OF THE INNER FRONT RING DETAIL (The much finer grain microstructure of the flange (lower) relative to the detail ring wall (upper) illustrates that this front flange is a repair replacement flange attached sometime in the service life of the case.)

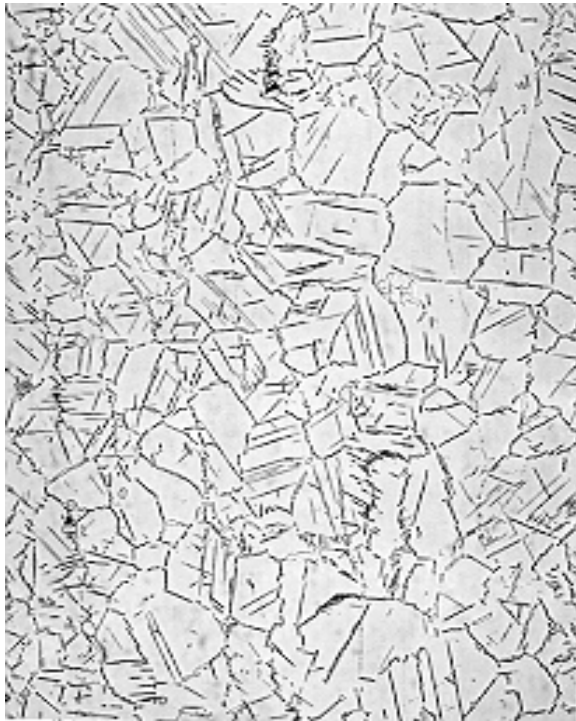
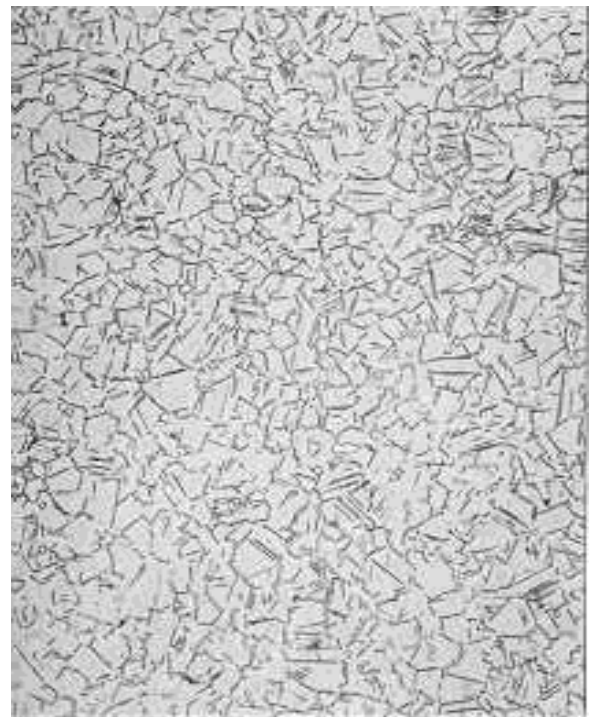
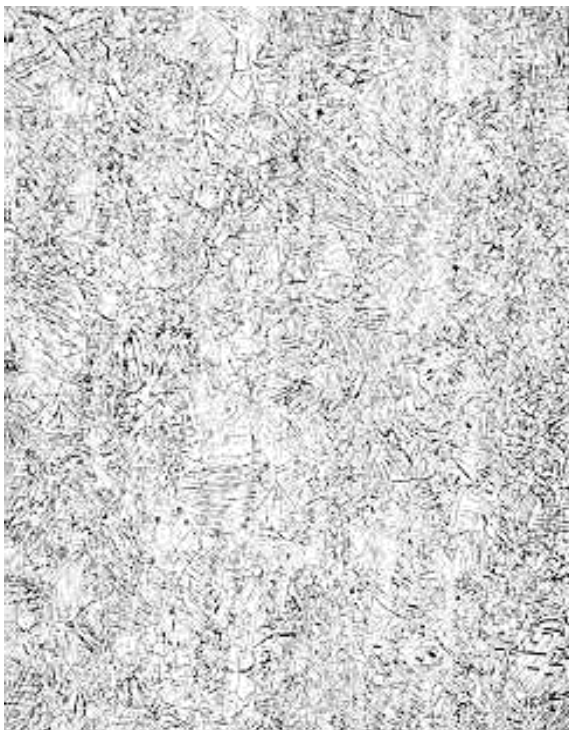
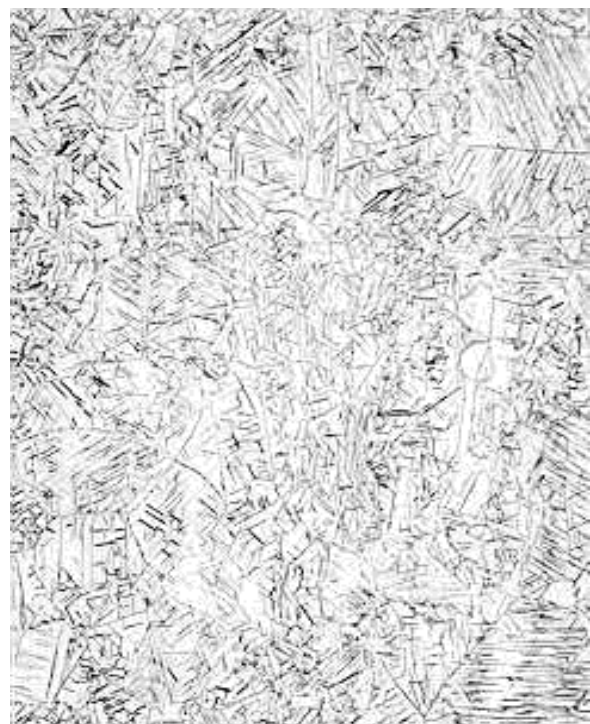
FIGURE D-10. JT9D DIFFUSER S/N BW0976, GENERAL MICROSTRUCTURES OF THE INNER REAR RING (UPPER) AND STRUT (LOWER) DETAILS

Grain size of the sheet material used to construct the struts was moderate fine grain (ASTM 6-7) but like the other sheet metal details displayed extensive amounts of needle delta phase scattered evenly throughout the microstructure.

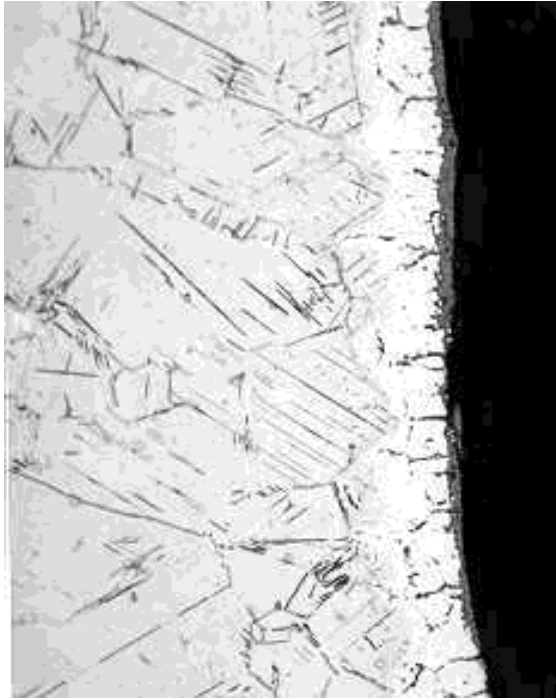
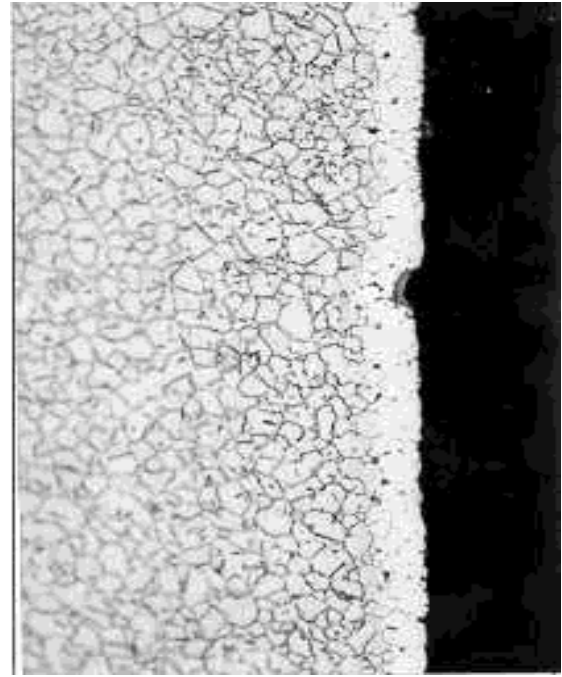
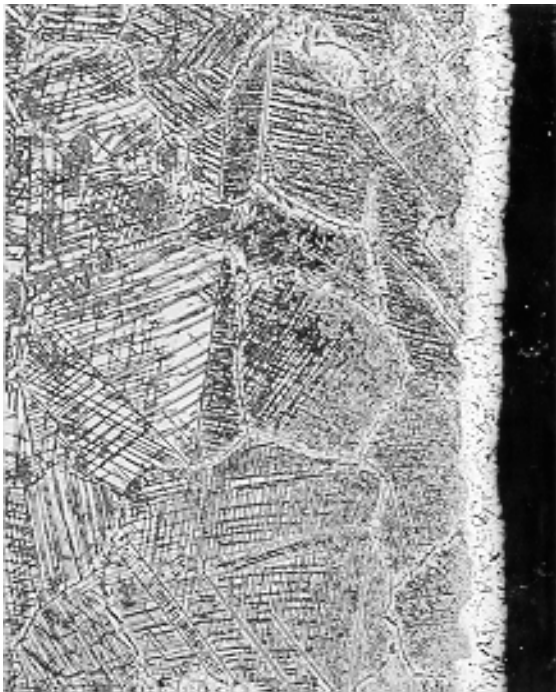
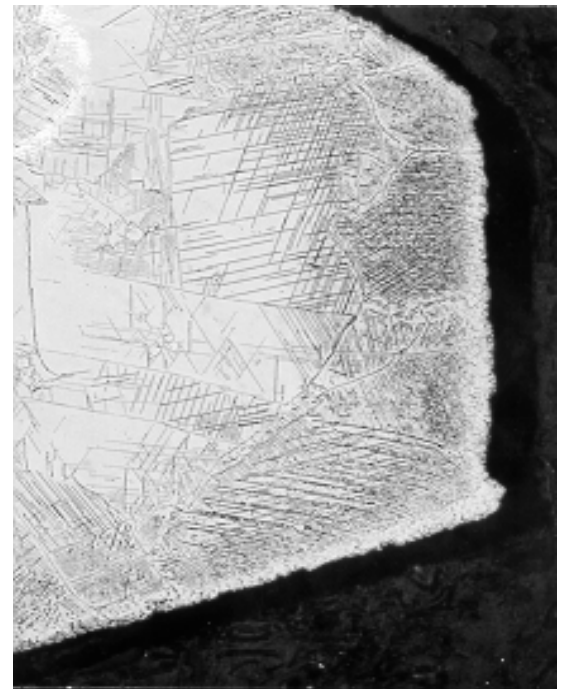
FIGURE D-11. JT9D DIFFUSER S/N BW0976, EXAMPLES OF SURFACE DEPLETION ON INNER CASE DETAILS (UPPER) AND CONCENTRATED NEEDLE DELTA ASSOCIATED WITH SOME SURFACES (LOWER LEFT) AND THREADS (LOWER RIGHT)

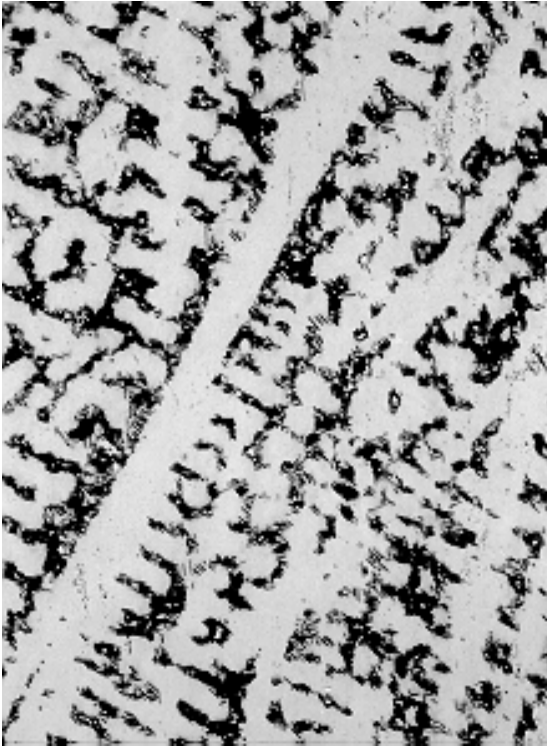
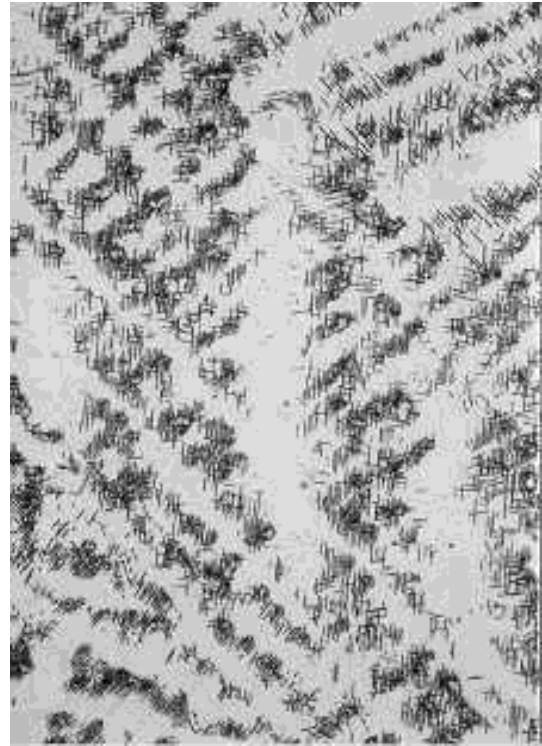
Assembly and repair welds on the outer pressure wall were generally sound but several contained large pools of laves phase. Often the adjacent base metal also contained very high concentrations of needle delta phase. Numerous cracks were observed emanating outward from the bracket to heat shield resistance weld and within the fusion zone of the heat shield/bracket assembly weld.

FIGURE D-12. JT9D DIFFUSER S/N BW0976, REPAIR WELD MICROSTRUCTURES
(The higher (slightly) concentration of needle delta in the weld located on the center ring (right) relative to the front skirt repair (left) suggests that the center ring repair was exposed to more re-solution heat treatments over the service life of the case.)

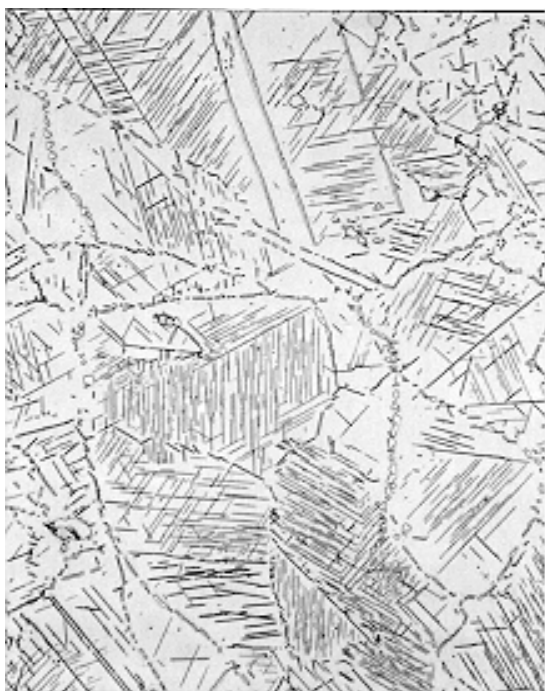
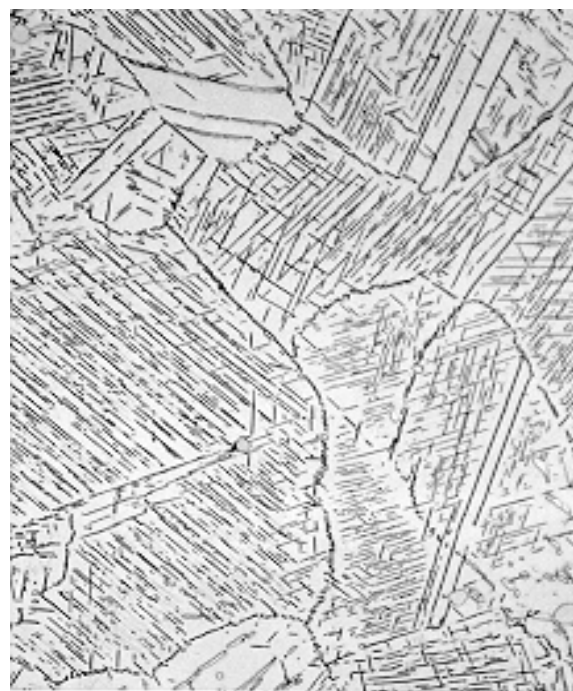
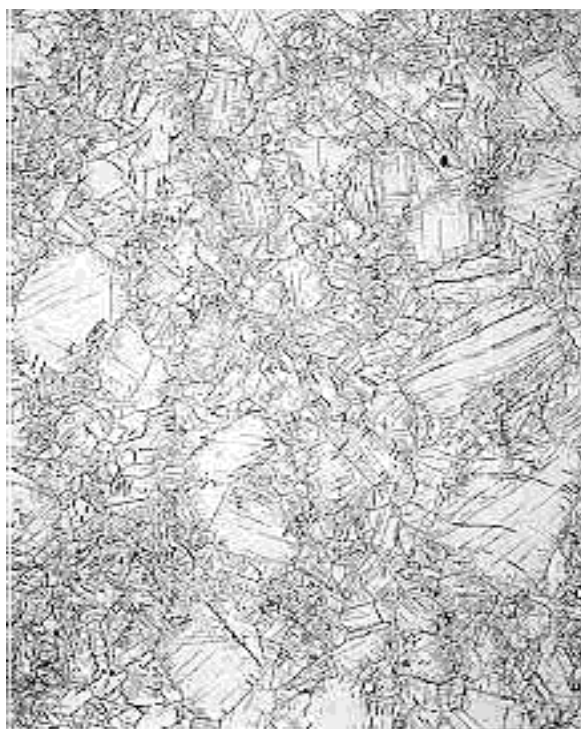
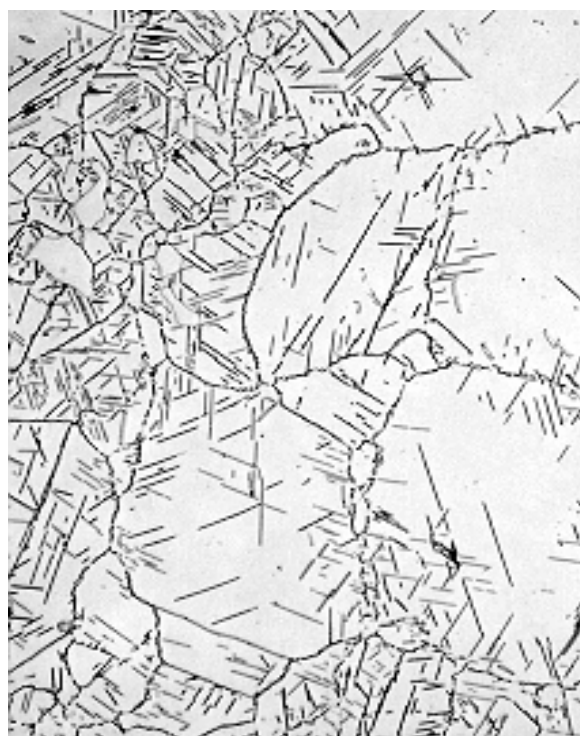
FIGURE D-13. JT9D DIFFUSER S/N CJ3225, GENERAL MICROSTRUCTURES OF THE OUTER FRONT SKIRT (UPPER) AND OUTER CENTER RING (LOWER) DETAILS

Within the outer pressure wall, heavy concentrations of needle-shaped delta phase were present throughout the forward skirt (and flange) and in patches and at grain boundaries of the center ring and rear skirt details. The rear skirt displayed the least of the patches but in the thicker sections of the skirt concentrations of needle delta could be extensive. The amount of evenly distributed delta phase in the forward and center rings made it difficult to ascertain if a surface layer of high delta phase concentration existed. However, a surface denuded layer of 0.00078" was observed on the forward skirt regions of the case. Heavy concentrations of delta needles were also observed associated with the tapped lugs on the forward skirt.

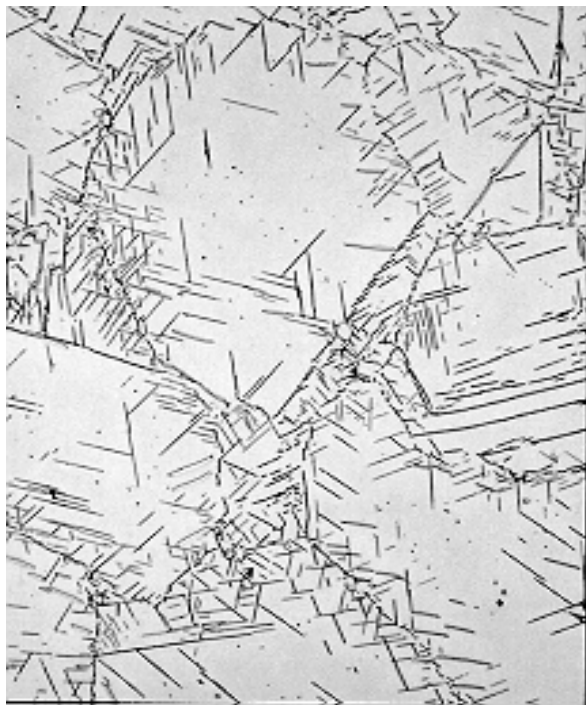
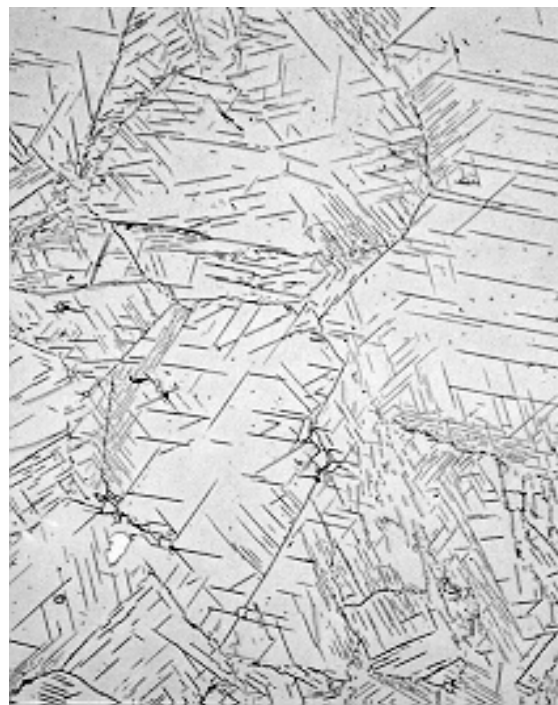
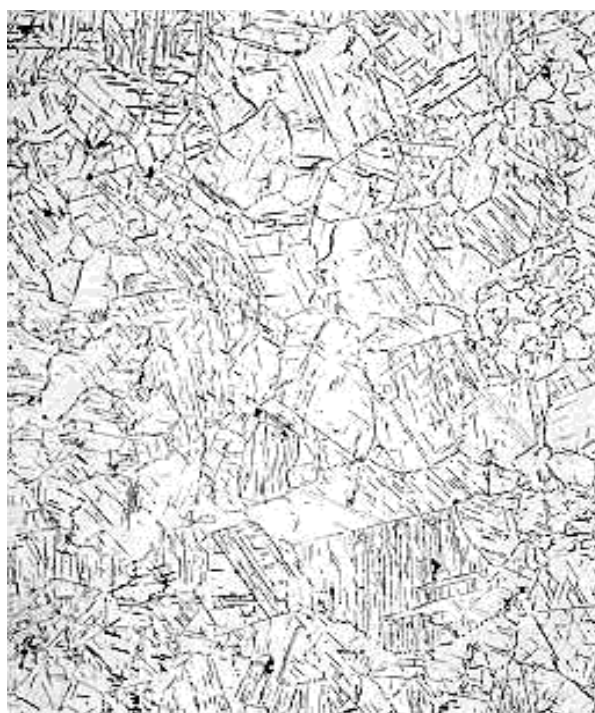
FIGURE D-14. JT9D DIFFUSER S/N CJ3225, GENERAL MICROSTRUCTURES OF THE INNER REAR RING (UPPER) AND STRUT (LOWER) DETAILS

The sheet metal struts were relatively fine grained with extensive needle delta phase scattered throughout.

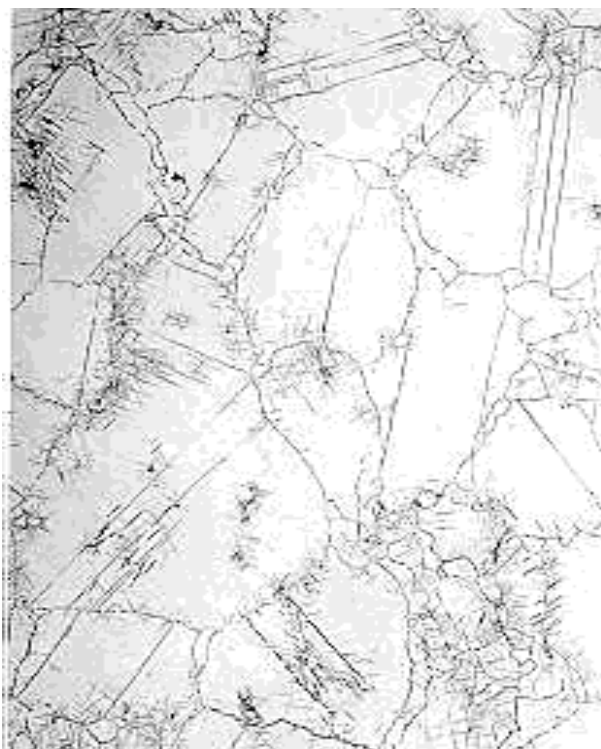
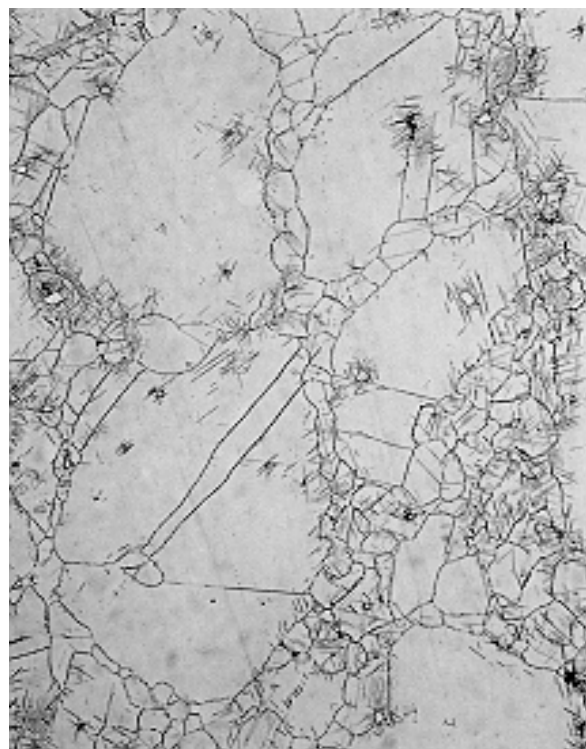
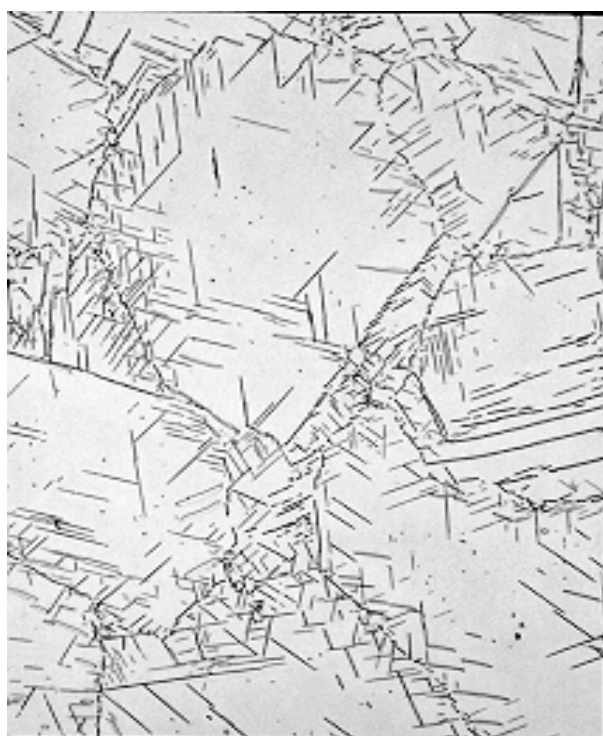
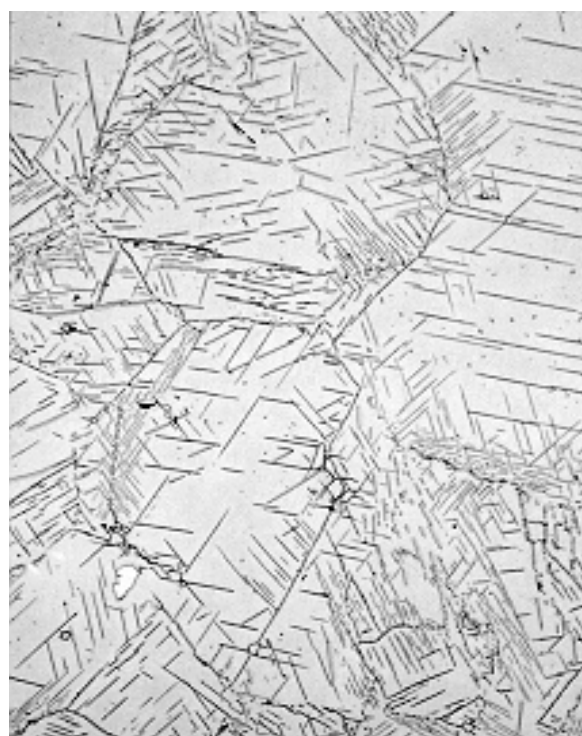
FIGURE D-15. JT9D DIFFUSER S/N CJ3225, GENERAL MICROSTRUCTURES OF THE INNER FRONT RING DETAIL

The forward ring (and flange) of the inner pressure wall consisted of a duplex microstructure, typically ASTM 4-5, in grain size, but many of the coarse grains were surrounded by a necklace structure of finer grains. The rear ring was finer grain sheet (ASTM 6-7) with heavy delta concentrations of delta phase throughout, while the rear flange was marked by delta phase concentrations in patches.

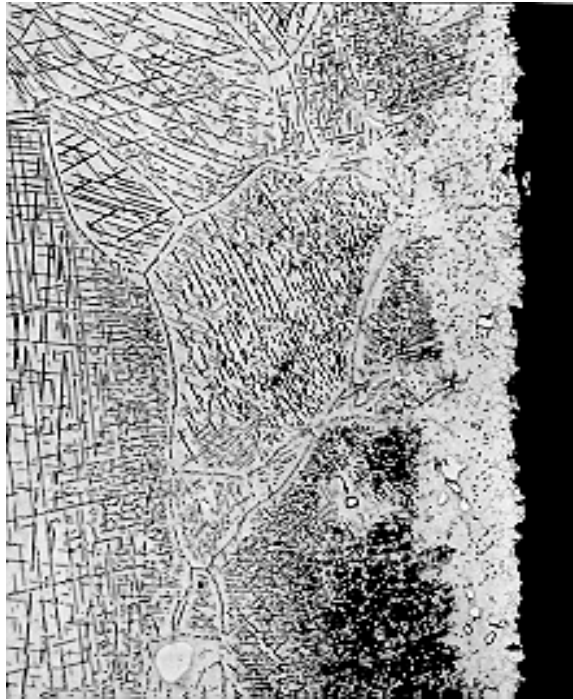
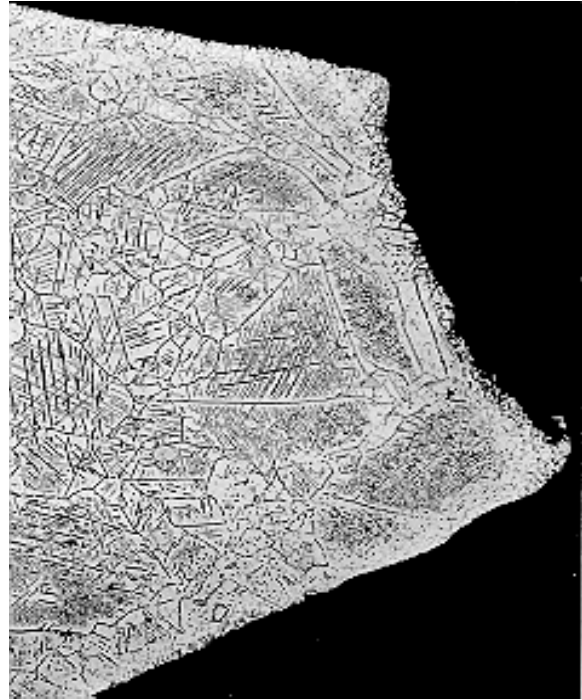
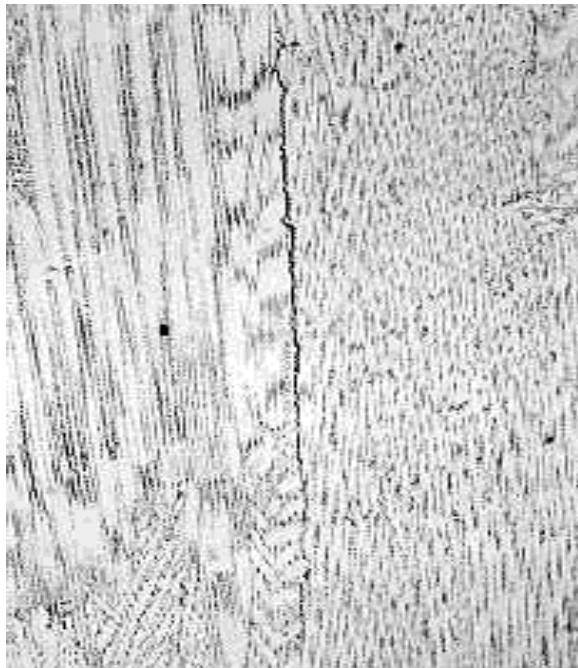
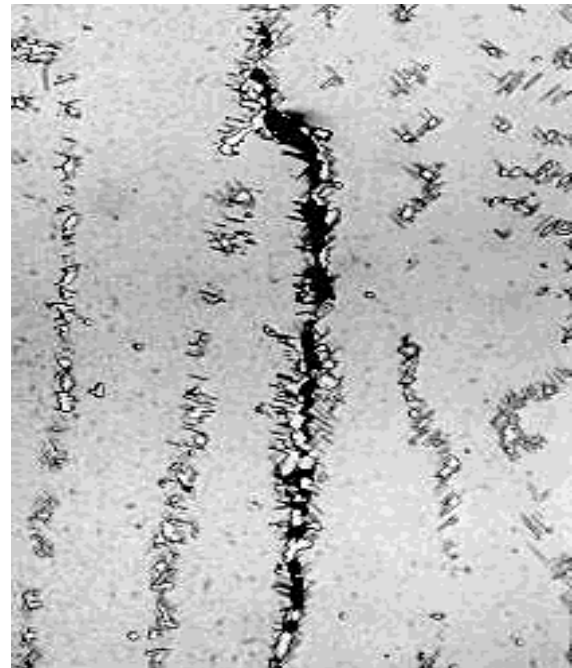
This case displayed many repair welds on the outer and inner pressure wall. Many of the welds also displayed subsurface cracks within the weld fusion zone. The numerous layers of weld bead observed suggest that many of the welds are repairs over previous welds. However, there is no way to prove this conclusively. Cracks, lack of fusion, and gas pores were all observed within the fusion zone material of the case. However, in many cases, these regions were actually HAZs to subsequent repairs.

FIGURE D-17. JT9D DIFFUSER S/N CJ3225, HEAVY CONCENTRATIONS OF NEEDLE DELTA ASSOCIATED WITH SOME SURFACES (UPPER LEFT) AND TAPPED HOLE THREADS (UPPER RIGHT) AND REPAIR WELD CRACKS (LOWER)
(The crack illustrated in the lower right figure is associated with interdendritic concentrations of laves phase.)
